# ES\_LPC43S5x/S3x Flash

Errata sheet LPC43S5x/S3x flash-based devices

Rev. 1.4 — 24 September 2019

Errata sheet

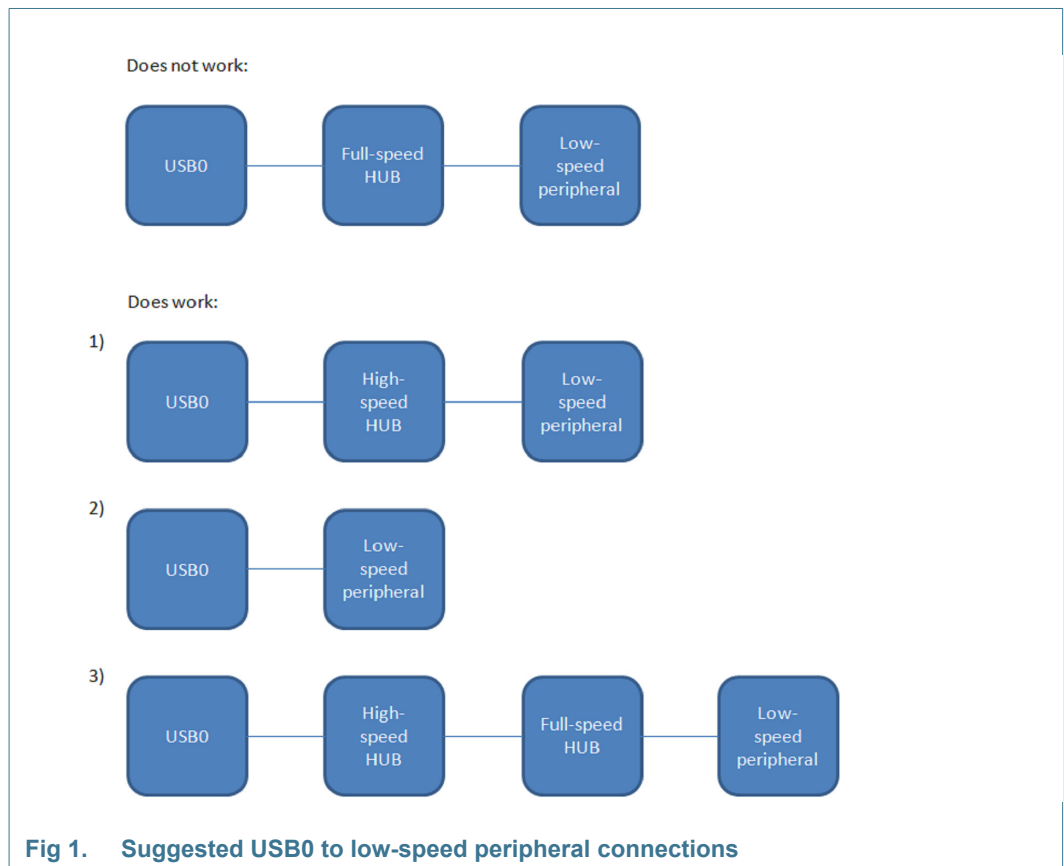
Fig 1. Suggested USB0 to low-speed peripheral connections

The USB controller called USB0 is unable to communicate with a low-speed USB peripheral in host mode when there is a full-speed hub directly connected to the USB0 port and a low-speed peripheral is connected in the tree somewhere below this full-speed hub. Only USB0 has this problem; the other USB controller, USB1 does not.

There is no work-around for this problem. It is suggested that the low-speed USB peripheral is either connected directly to USB0 or a high-speed hub is placed between that peripheral and USB0.
