# KwikStik-K40

## Hardware Errata

Rev. 5

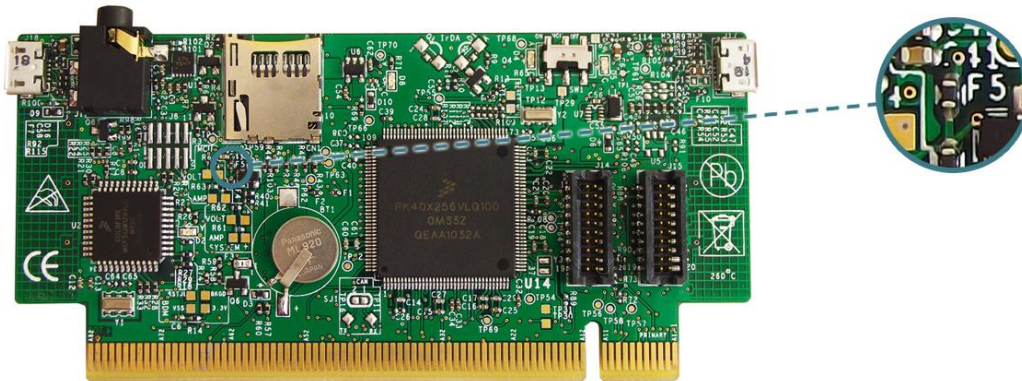
When the ON/OFF switch SW1 is in the OFF position, the K40 MCU is not turned off. This can cause unexpected behavior when trying to use the JTAG connector for external device programming and debugging.

Removing power supply to VREFH will allow the K40 to be switched off. To do so, remove ferrite F5.

This issue is fixed starting in version 4.

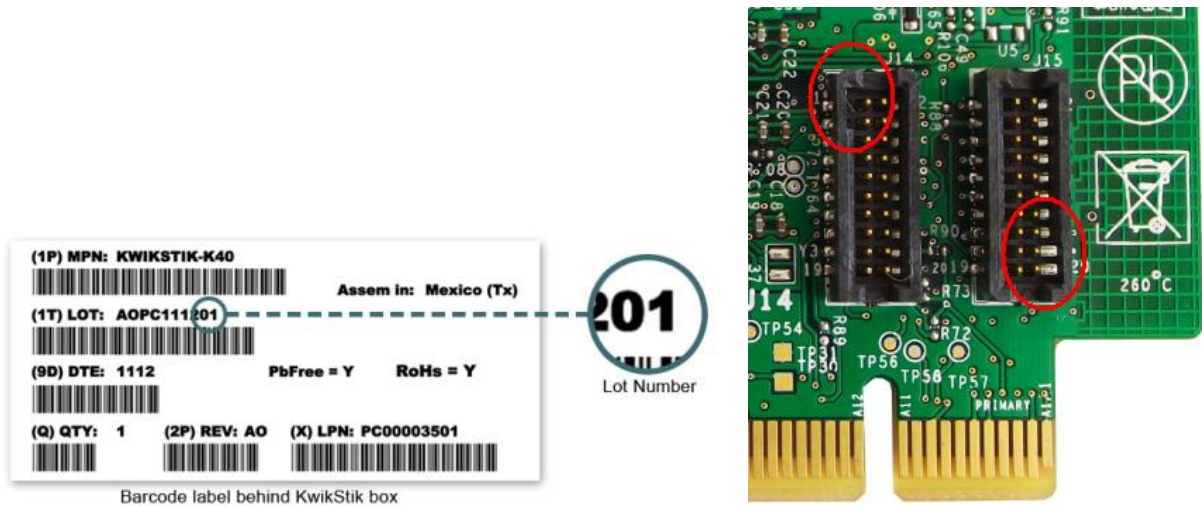
KWIKSTIK-K40 PWA Rev A/3.0 Boards of shipment lots 01-04 may have the TWRPI connectors (J14, J15) populated in a wrong orientation.

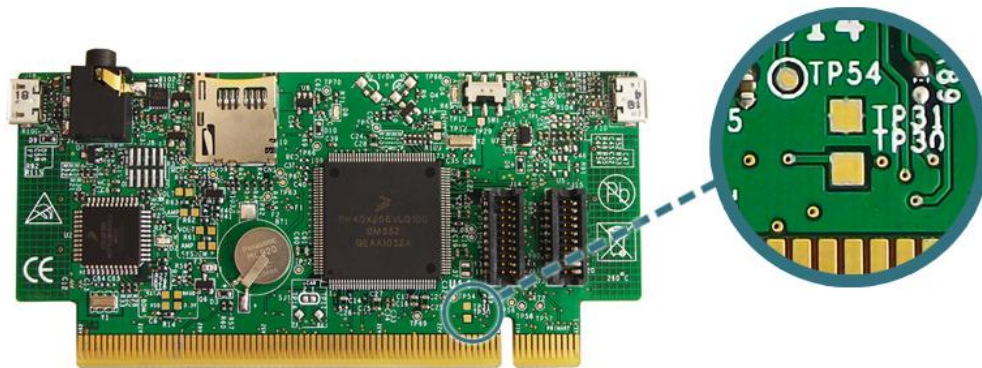
VBAT signal is not powered in KWIKSTIK-K40 PWA Rev A/3.0 boards, making the RTC module unusable.

To use the RTC module, power must be supplied to VBat on TP30.

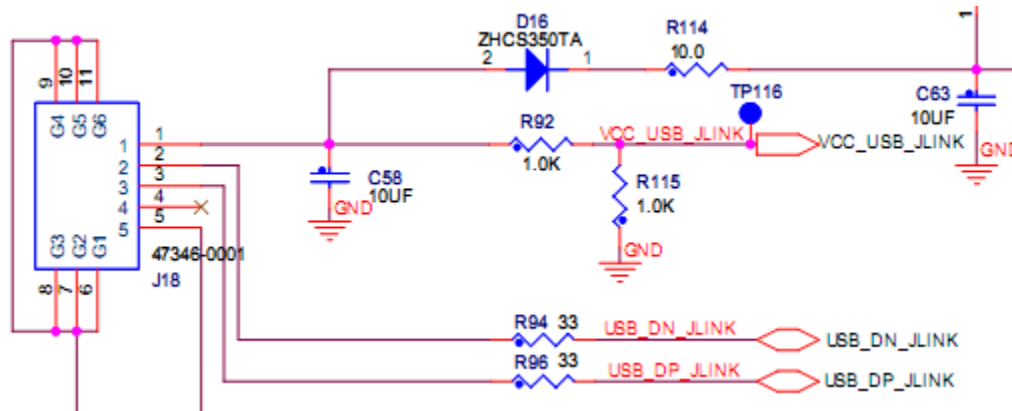
R114 is identified as a 10.0Ω resistor on the schematics but may be populated with a 0Ω resistor. When power is applied to the J-Link USB connector, J18, current will flow through D16 and R114 to charge C63 and provide power to the +5V\_USB supply. D16 is rated for 500mA. Without a resistance on R114 D16 may exceed its rating and it may fail to operate correct resulting in the inability to power the KwikStik from the J-Link USB connector.

Replace R114 with a 10Ω resistor. Power may still be applied to the other USB connector, J17 to source power to the entire Kwikstik, including the J-Link circuit. If powered from J17, the J-Link interface will continue to operate properly as a debug interface.
