Mask Set Errata

MSE908AS60_8H62A
12/2002

Mask Set Errata for 908AS60,
Mask 8H62A

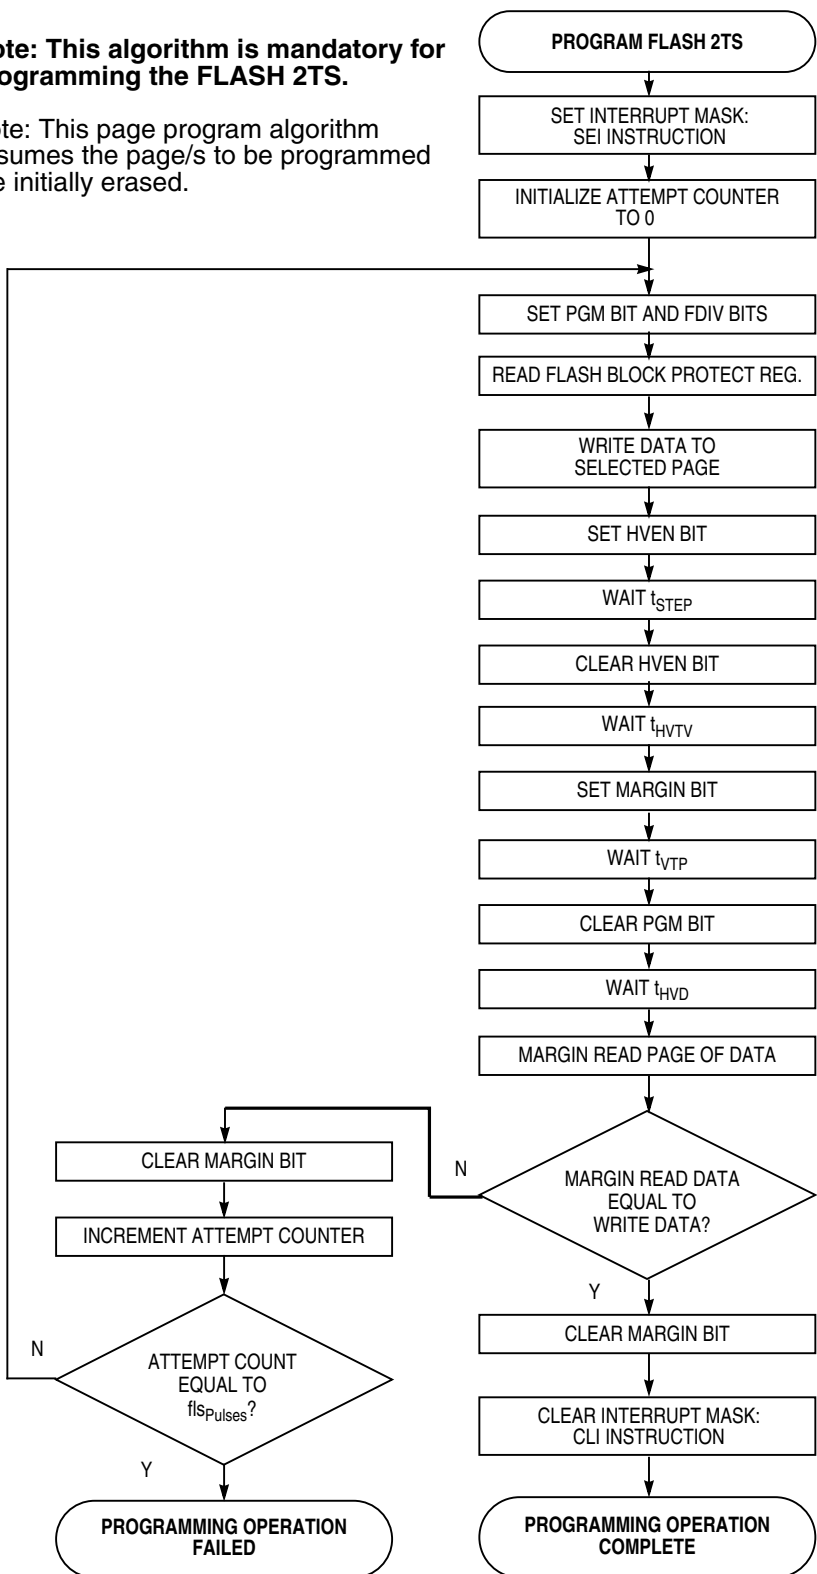
Figure 1. Smart Programming Algorithm, Page Program/Margin Read Procedure

Use of the smart programming algorithm, the iterative page program/margin read technique, is required.

When using the iterative page program/margin read technique, a maximum of 100 programming pulses is allowed. The minimum duration of the programming pulse (t_{STEP}) shall be 1 ms. The t_{STEP} duration is defined as the amount of time during one program cycle that HVEN is asserted ($HVEN = 1$). The maximum t_{STEP} is 1.2 ms. Therefore, the maximum cumulative program time (t_{PROG}) per page is 120 ms.

Cumulative program time exceeding 100 steps per page may cause unintentional programming of erased bits. This condition is known as program disturb.
