# Mask Set Errata for 68HC912D60A, Mask 0M35Z

This mask set errata applies to this 68HC912D60A MCU mask set:

- 0M35Z

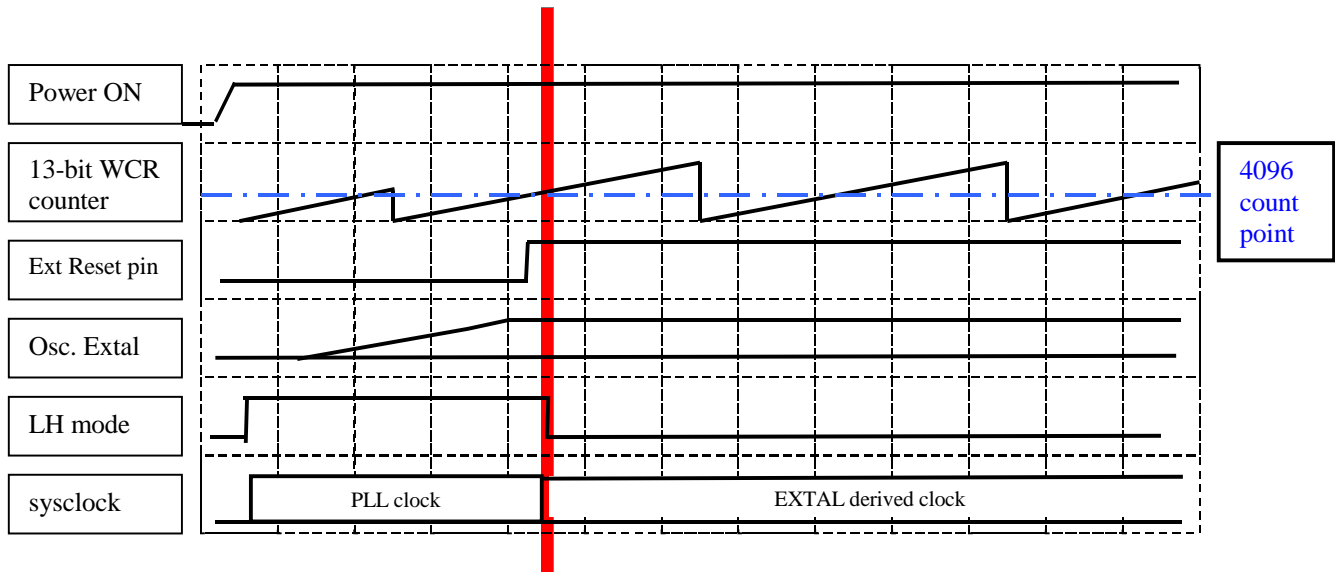
Figure 1. Representation of Normal start-up condition

Common practice for the start up mode of operation of HC12 microcontrollers is for the external RESET line to be held active until such time as the crystal has stabilized at its operating frequency. On release of the external RESET line and when the WCR (counter register) reaches a count of 4096 cycles, normal operating mode is entered with the CPU clocked from the crystal frequency (see fig. 1).

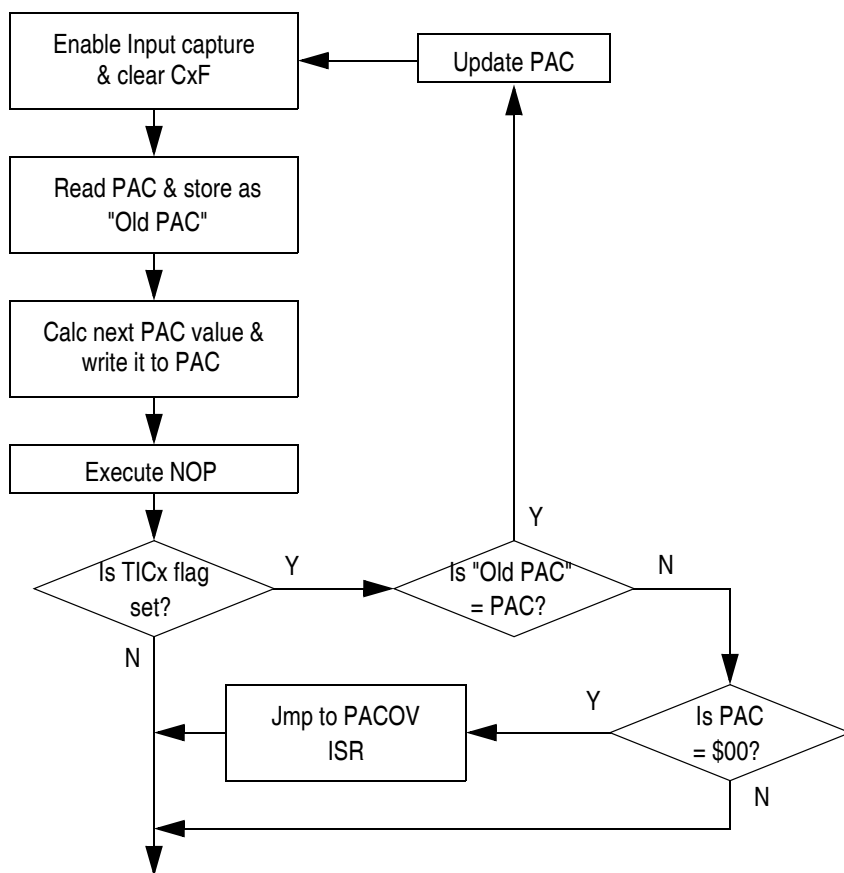
When the value \$FFFF is written to PACA or PACB and, at the same time, an external clocking pulse is applied to the PAC, the pulse accumulator may overflow from \$FFFF to \$0000, but the pulse accumulator overflow flag [PAFLG,PBFLG] is not set. Same situation may happen with 8-bit pulse accumulators PAC1 and PAC3.

The input capture function for the subject channel be enabled prior to writing a value to the PACA or PACB. Write to the pulse accumulator register. Then do one NOP (to allow the input capture to update the interrupt flag) followed by a read of the input capture interrupt flag to see if it set. If yes, a check must be made for a missing pulse accumulator event. Steps for software workaround to see if event happens while writing to PAC:

1. Enable Input Capture on same pin as the pulse accumulator (and same type of event).
2. Clear the appropriate CxF in the timer interrupt flag register.
3. Read PAC and store as "Old PAC".
4. Calculate desired PAC value and write it to the PAC.
5. Execute 1 NOP.
6. Read CxF in the timer interrupt flag register.
