Mask Set Errata for 68HC912DT128A, Mask 0M63Z

This mask set errata applies to this 68HC912DT128A MCU mask set:

- 0M63Z

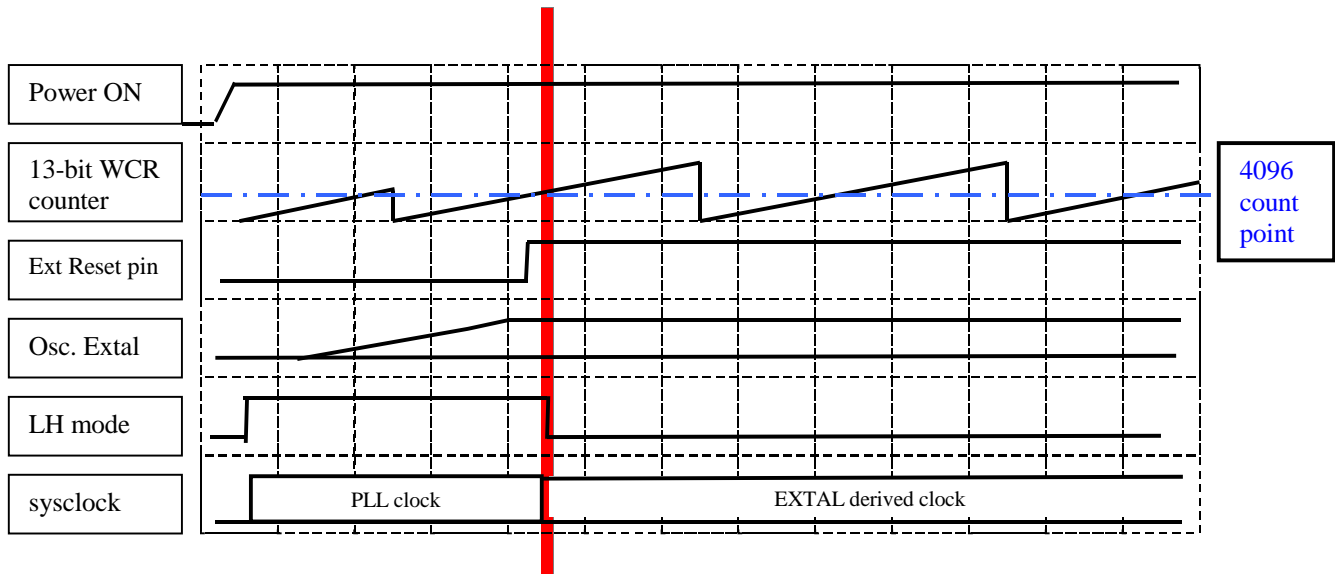
Common practice for the start up mode of operation of HC12 microcontrollers is for the external RESET line to be held active until such time as the crystal has stabilized at its operating frequency. On release of the external RESET line and when the WCR (counter register) reaches a count of 4096 cycles, normal operating mode is entered with the CPU clocked from the crystal frequency (see fig. 1).

Figure 1. Representation of Normal start-up condition

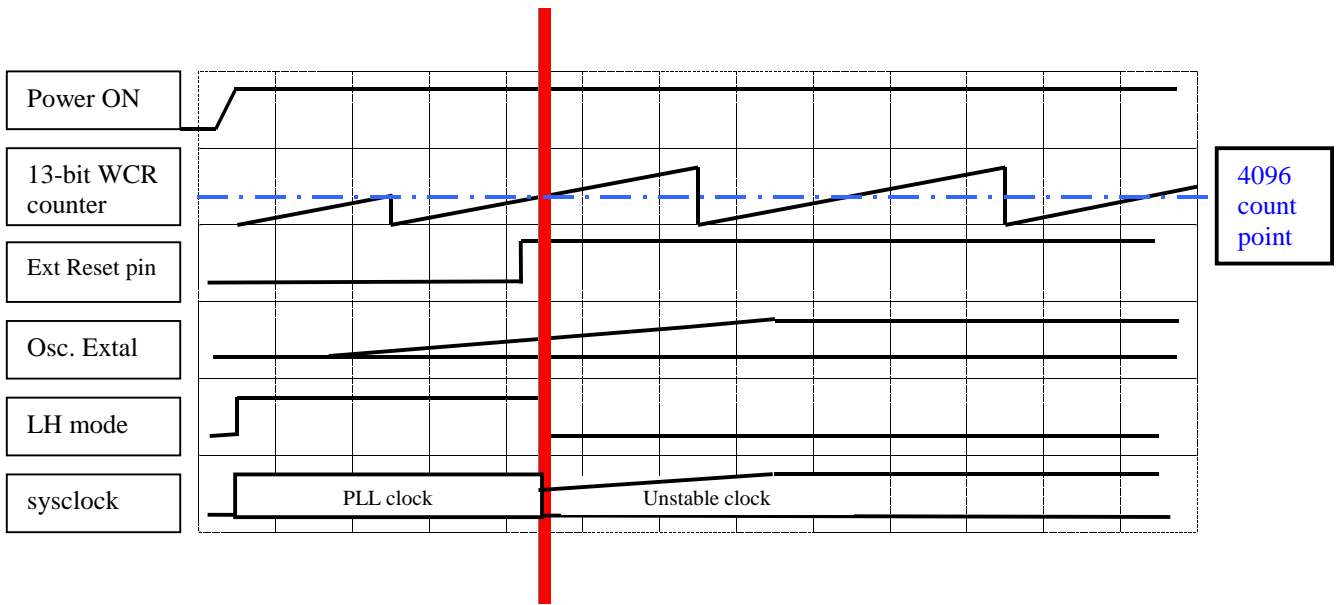
For the first 4096 cycles i.e. during the internal reset period, Limp Home mode will be de-asserted if oscillator activity is detected by the clock monitor circuit -due to the asserted Reset signal there can be no CPU activity during the Reset phase. Following release of the external or internal POR RESET in LHM (which ever is later) the crystal oscillator is sampled by the clock monitor circuit after another 4096 VCO clock cycles and at intervals of 8192 clock cycles thereafter until the crystal is deemed to be operating. If the crystal oscillator is showing activity at the time it is checked then it will be deemed to be good, even though it may not have fully stabilized, and LHM will be de-asserted. This can cause the device to switch from LH mode to normal mode with the CPU clocked from an unstable signal from the crystal oscillator (see fig. 2) resulting in unpredictable function of the CPU.

Figure 2. Representation of unreliable start-up mode with slow crystal

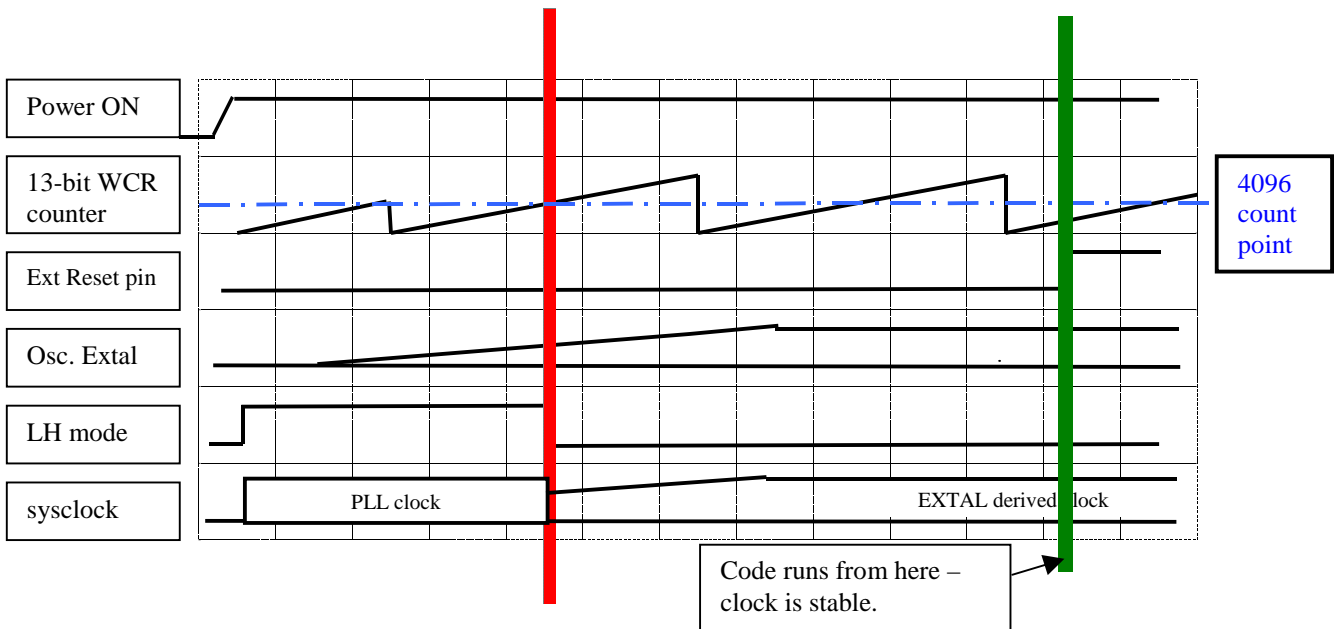
Figure 3. Representation of preferred means of overcoming issue with Figure 2

The Reset condition can be overcome by allowing the crystal oscillator circuit to stabilize before releasing the external RESET line (see fig. 3). Operation is similar to that shown in fig 2.

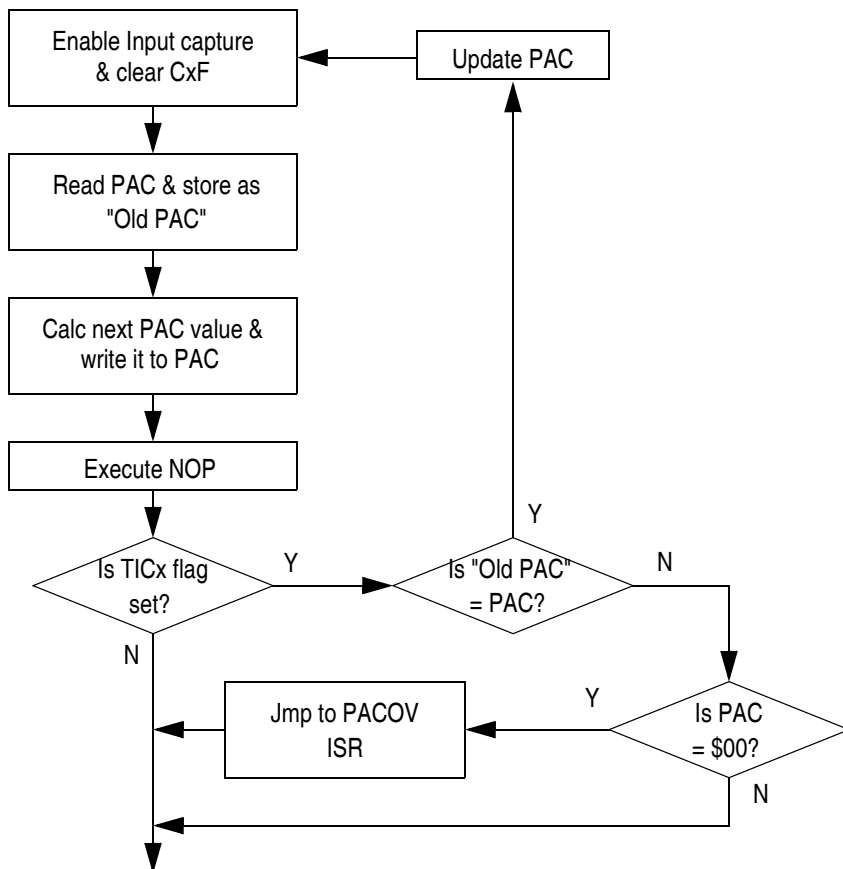
When the value \$FFFF is written to PACA or PACB and, at the same time, an external clocking pulse is applied to the PAC, the pulse accumulator may overflow from \$FFFF to \$0000, but the pulse accumulator overflow flag [PAFLG,PBFLG] is not set. Same situation may happen with 8-bit pulse accumulators PAC1 and PAC3.

The input capture function for the subject channel be enabled prior to writing a value to the PACA or PACB. Write to the pulse accumulator register. Then do one NOP (to allow the input capture to update the interrupt flag) followed by a read of the input capture interrupt flag to see if it set. If yes, a check must be made for a missing pulse accumulator event. Steps for software workaround to see if event happens while writing to PAC:

1. Enable Input Capture on same pin as the pulse accumulator (and same type of event).
2. Clear the appropriate CxF in the timer interrupt flag register.
3. Read PAC and store as "Old PAC".
4. Calculate desired PAC value and write it to the PAC.
5. Execute 1 NOP.
6. Read CxF in the timer interrupt flag register.
