## Mask Set Errata

MSE912DT128A\_4K91D  
Rev 0.0, 01/2003

Mask Set Errata for  
68HC912DT128A  
Mask 4K91D

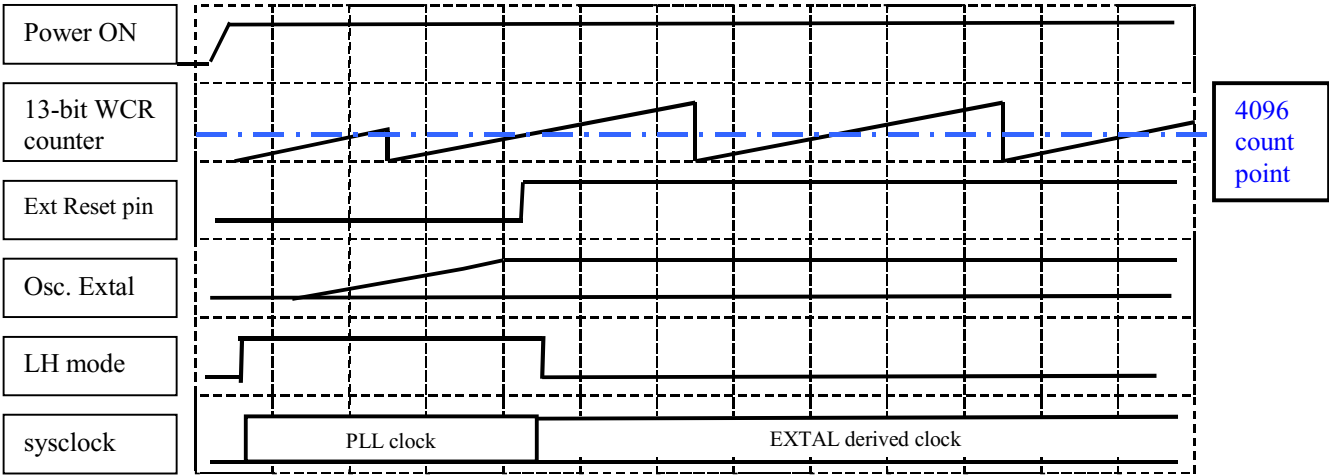
**Figure 1. Representation of Normal start-up condition**

Common practice for the start up mode of operation of HC12 microcontrollers is for the external RESET line to be held active until such time as the crystal has stabilized at its operating frequency. On release of the external RESET line and when the WCR (counter register) reaches a count of 4096 cycles, normal operating mode is entered with the CPU clocked from the crystal frequency (see fig. 1).

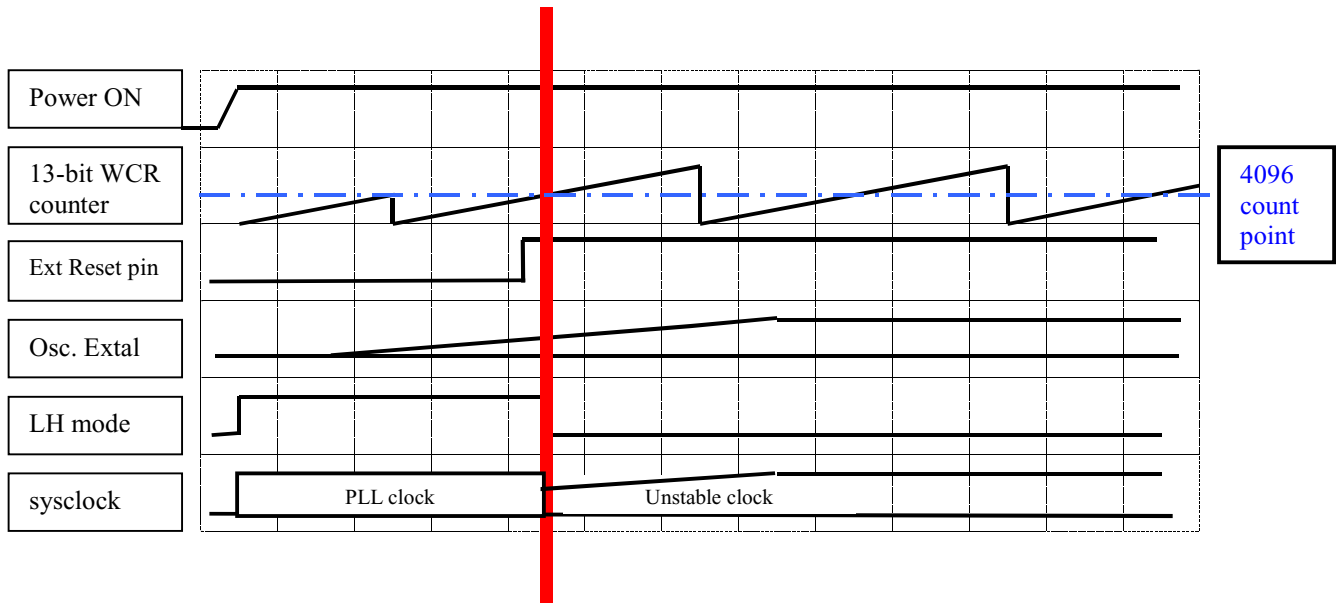
**Figure 2. Representation of unreliable start-up mode with slow crystal**

The HC12 mode of operation known as Limp-Home Mode (LHM) is enabled when the VDDPLL pin is at VDD and is entered if for any reason the external crystal ceases to oscillate. During this mode the CPU will be clocked from the free-running VCO clock of the PLL (at a nominal frequency of 1MHz). If LHM is enabled during the start-up phase (i.e. VDDPLL=5V, NOLHM bit=0) and the external RESET line is not held active until after the crystal frequency is stable then the device starts up in LHM since no crystal oscillations will be detected. This situation can arise with short reset periods and/or crystals that exhibit slow start-up characteristics.

For the first 4096 cycles i.e. during the internal reset period, Limp Home mode will be de-asserted if oscillator activity is detected by the clock monitor circuit - due to the asserted Reset signal there can be no CPU activity during the Reset phase. Following release of the external or internal POR RESET in LHM (whichever is later) the crystal oscillator is sampled by the clock monitor circuit after another 4096 VCO clock cycles and at intervals of 8192 clock cycles thereafter until the crystal is deemed to be operating. If the crystal oscillator is showing activity at the time it is checked then it will be deemed to be good, even though it may not have fully stabilized, and LHM will be de-asserted. This can cause the device to switch from LH mode to normal mode with the CPU clocked from an unstable signal from the crystal oscillator (see fig. 2) resulting in unpredictable function of the CPU.

The Reset condition can be overcome by allowing the crystal oscillator circuit to stabilize before releasing the external RESET line (see fig. 3). Operation is similar to that shown in fig 2.

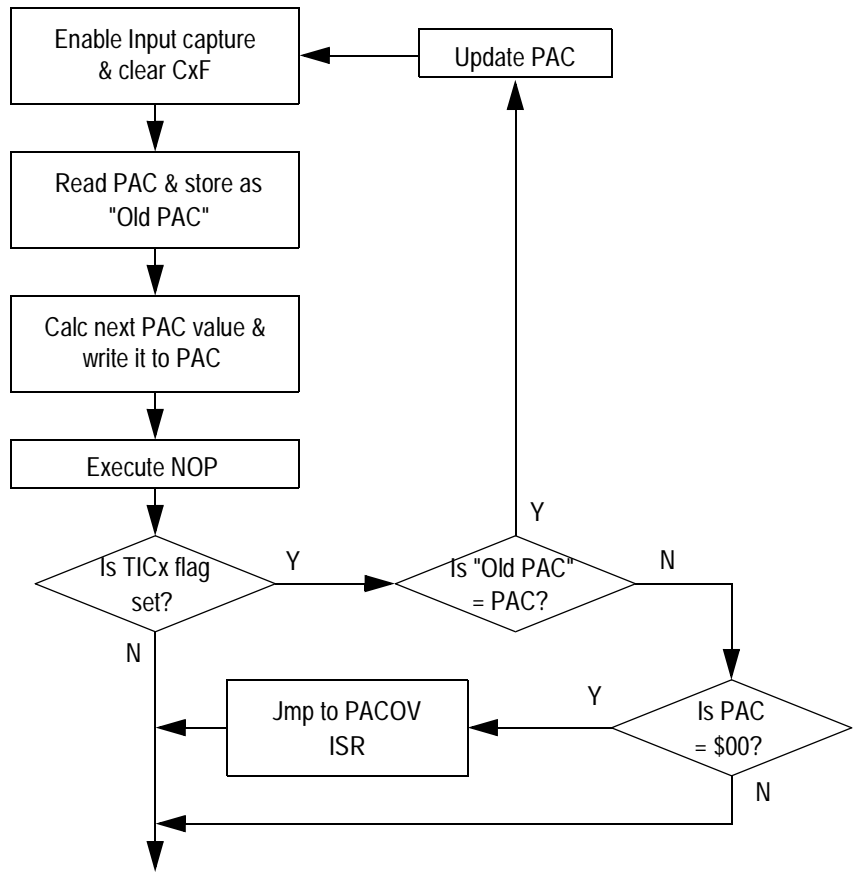
**Description** When the value \$FFFF is written to PACA or PACB and, at the same time, an external clocking pulse is applied to the PAC, the pulse accumulator may overflow from \$FFFF to \$0000, but the pulse accumulator overflow flag [PAFLG,PBFLG] is not set. Same situation may happen with 8-bit pulse accumulators PAC1 and PAC3.

**Workaround** The input capture function for the subject channel be enabled prior to writing a value to the PACA or PACB. Write to the pulse accumulator register. Then do one NOP (to allow the input capture to update the interrupt flag) followed by a read of the input capture interrupt flag to see if it set. If yes, a check must be made for a missing pulse accumulator event. Steps for software workaround to see if event happens while writing to PAC:

1. Enable Input Capture on same pin as the pulse accumulator (and same type of event).
2. Clear the appropriate CxF in the timer interrupt flag register.
3. Read PAC and store as "Old PAC".
4. Calculate desired PAC value and write it to the PAC.
5. Execute 1 NOP.
6. Read CxF in the timer interrupt flag register.
