Mask Set Errata for Mask 3L31R

This report applies to mask 3L31R for these products:

- MC9S08GB60
- MC9S08GT60
- MC9S08GB32
- MC9S08GT32
- MC9S08GT16

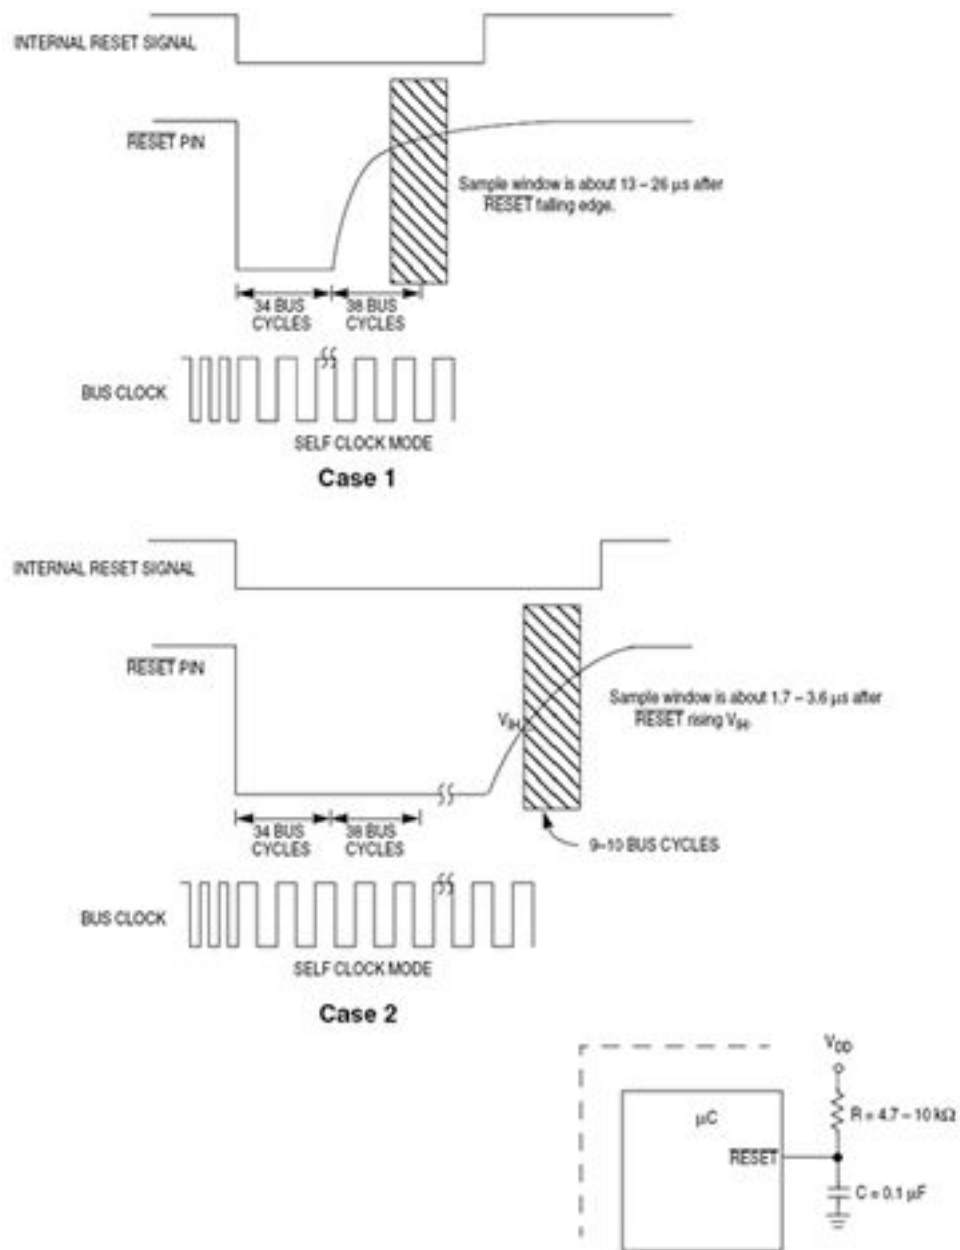
Figure 1. HCS08 SIM Reset Lockup

SE94A-Reset: HCS08 with ICG — Falling Edge on $\overline{\text{RESET}}$ During Termination of Reset Events

Description: If a falling edge is detected on the external reset pin at either of two sample points, the MCU will cease operation and will recover only after a power-on reset.

After detecting a reset signal, either internal or external, the internal reset circuit latches the cause of the reset, forces a low level on the external RESET pin for about 34 bus cycles, releases the pin, and samples the pin level about 38 bus cycles later. The ICG will revert to self-clock mode (SCM) at the beginning of the reset cycle. Therefore, the first sample window is about 13 μs to 26 μs after the initial reset signal, due to the frequency range and characteristics of the internal oscillator.

After remaining in reset for an extended period of time due to an externally applied low level on RESET, the internal reset circuit will sample the pin level about 9 to 10 bus cycles after the pin raises above its V_{IH} level. The ICG will revert to self-clock mode (SCM) during reset. Therefore, the second sample window is about 1.7 μs to 3.6 μs after the reset signal rises above V_{IH} , due to the frequency range and characteristics of the internal oscillator.

Workaround: To avoid multiple edges on the RESET pin due to switch contact ringing or EMC noise, eliminate any voltage bounce through RC filtering. A 0.1 μF capacitor to ground and an external 4.7 k Ω to 10 k Ω resistor to V_{DD} works well to ensure noise suppression.

In addition to RC filtering, avoid spurious edges on the RESET pin caused by external active circuitry such as low voltage detectors and watchdog components. Do this by ensuring that external circuitry cannot drive RESET low within 10 bus cycles of the release of RESET.
