*MPC8240CE
Rev. 5, 1/2004*

*MPC8240
Integrated Processor
Chip Errata*

Freescale Semiconductor, Inc.

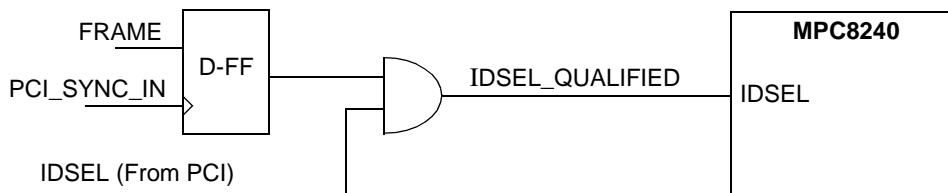
Figure 1. IDSEL Qualifying Logic

If the above conditions occur when the MPC8240 is not the target of the transaction, the MPC8240 will assert $\overline{\text{SERR}}$ if bit 8 of the PCI Command Register <0x04> is set. $\overline{\text{SERR}}$ will oscillate in this manner: $\overline{\text{SERR}}$ will be driven low for two clocks and then three-stated for two clocks. The first occurrence of $\overline{\text{SERR}}$ asserting will be three clocks after the detected event.

In host mode, we recommend to pulldown the IDSEL input on the MPC8240. In general, this is an acceptable solution for host mode operation as PCI configuration cycles are normally issued by the host controller.
