LS2085_88ARDBE

LS2085A/LS2088A Reference Design Board Errata

Rev. 3 — 28 May 2021

Errata

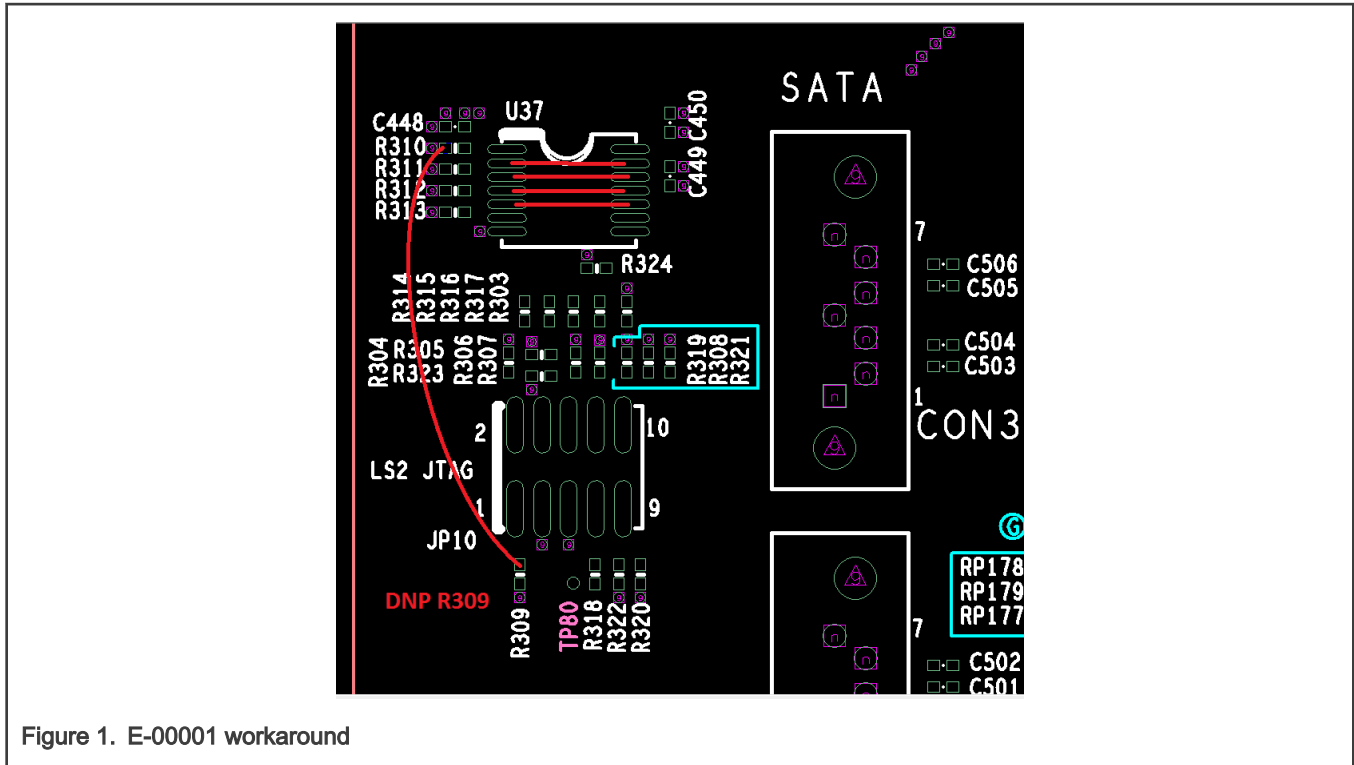
Figure 1. E-00001 workaround

E-00001: JTAG voltage translator U37 is not required

The U37 voltage translator impacts the signal integrity of the JTAG bus.

The CodeWarrior TAP device does not work with the U37 voltage translator installed on the board.

Remove the U37 voltage regulator and R309 resistor and solder the wires as listed below.

- R310 pin 1 to R309 pin 1
- U37 pin 2 to U37 pin 13
- U37 pin 3 to U37 pin 12
- U37 pin 4 to U37 pin 11
- U37 pin 5 to U37 pin 10

The above mentioned rework has been implemented on all Rev B boards. The permanent fix will be available on Rev. C boards.

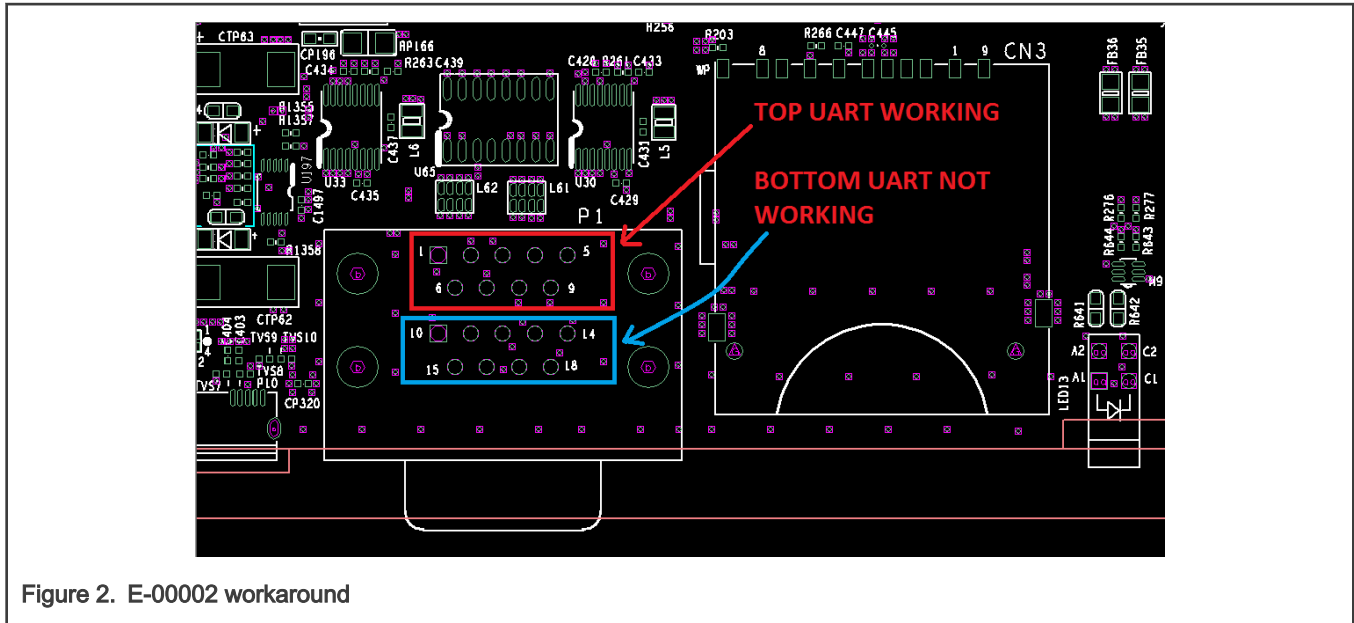
Figure 2. E-00002 workaround

E-00002: COM1 (UART 1/3) port is not working

The bottom port UART 1/3 is not working. It is wired incorrectly.

User cannot use the bottom port, UART 1/3.

Use the UART 2/4 top port.

The issue will be fixed on Rev. C boards.

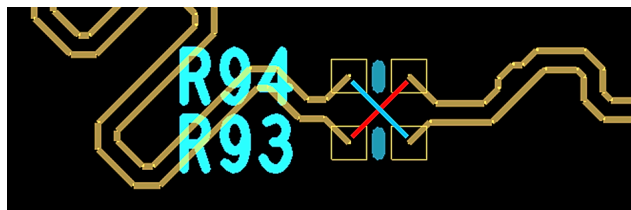
Figure 3. E-00005 workaround

E-00005: DDR4 connector U6 signals D2_MCLK1P and D2_MCLK1N are reversed

The D2_MCLK1P and D2_MCLK1N signals are mistakenly reversed in the schematic and in the layout.

The DDR controller 2 will not work. The errata impacts Rev. B and Rev. C boards.

Remove the R93 and R94 resistors and solder jumpers as listed below.

- R93 Pin1 to R94 Pin2 (need posted insulating tape)
- R94 Pin1 to R93 Pin2

All Rev B and Rev C boards will have this rework implemented before shipping. Therefore, no visible impact to the end user. The permanent fix will be implemented on Rev. D boards.

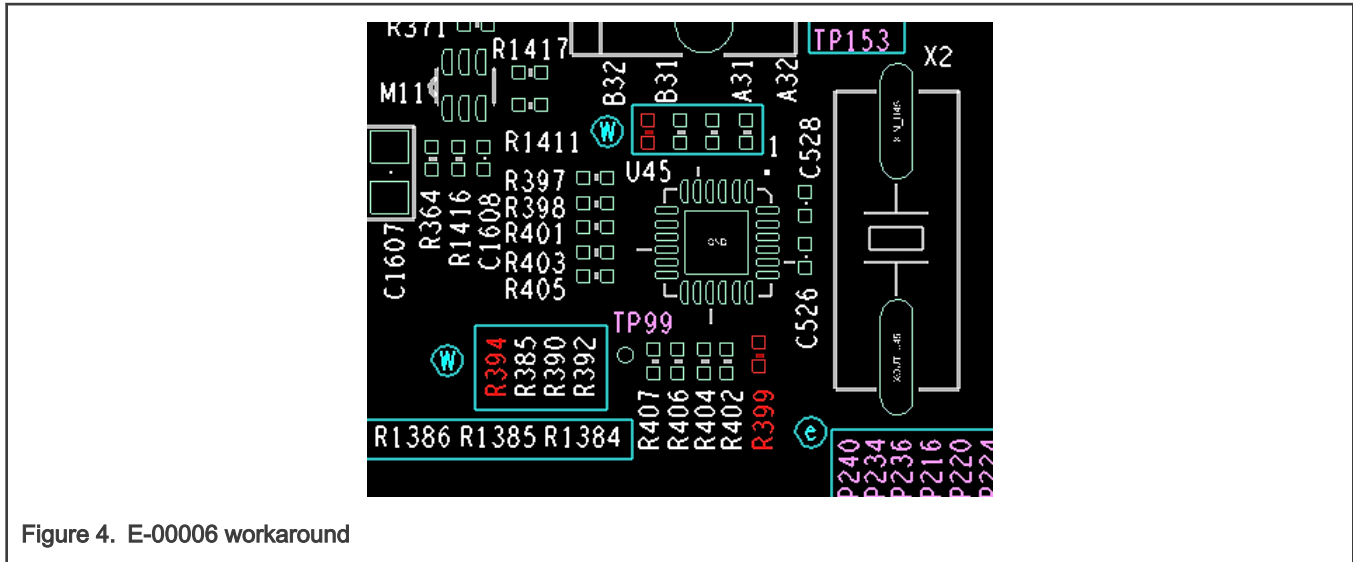
Figure 4. E-00006 workaround

E-00006: Clocks are not generated properly to PCIe slots

The 100 MHz clocks are not generated properly to the PCIe slots.

The x8 and x4 PCIe slots are not operational.

Remove the R399 and R394 resistors.

All Rev. B and Rev. C boards will have this fix implemented before shipping. Therefore, no visible impact to the end user. The permanent fix will be implemented on Rev. D boards.

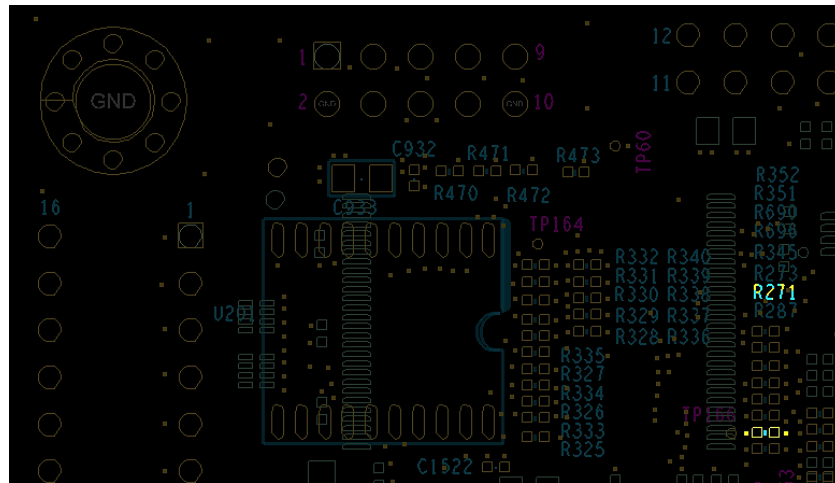
Figure 5. E-00007 workaround

E-00007: CFG_TESTSEL_B cannot be driven low

CFG_TESTSEL_B has both, a weak pulldown and a stronger pull-up. The SW8[5] switch cannot affect the TESTSEL level.

The alternate LS2085A/LS2088A personalities cannot be selected.

Rev. B/C: Remove the R271 resistor from the bottom of the board as shown in the image below.

Rev. D and later: Use CPLD v1.18 or later. The R271 resistor does not need to be removed.

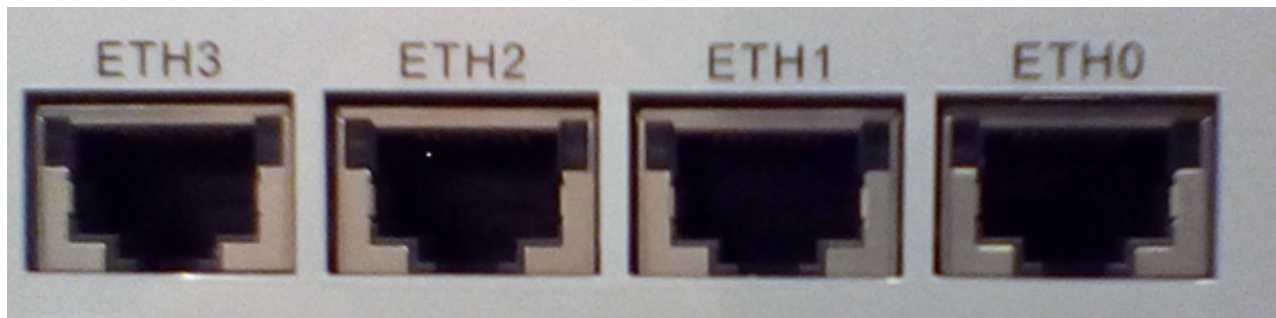
Figure 6. E-00008 workaround

E-00008: Only two 10 Gbit Ethernet copper ports can operate at a time

The power supply to the Aquantia 10 Gbit Ethernet PHY is inadequate on Rev. B and Rev. C boards. As a result, only two 10 Gbit Ethernet copper ports can be enabled at a time instead of all four copper ports.

Any two 10 Gbit Ethernet copper ports can be used or enabled under this restriction. The LS2085A/LS2088ARDB software enables the ETH0 (DPNI7) and the ETH2 (DPNI9) copper ports by default.

No viable workaround to enable all four Ethernet ports. User is restricted to use only two 10 Gbit copper ports at a time. Currently, the software enables the ETH0 (DPNI7) and ETH2 (DPNI9) ports by default.

The power supply is fixed on Rev. D and later boards. Therefore, all four 10 Gbit Ethernet copper ports can be used on Rev. D and later boards with no port restrictions.

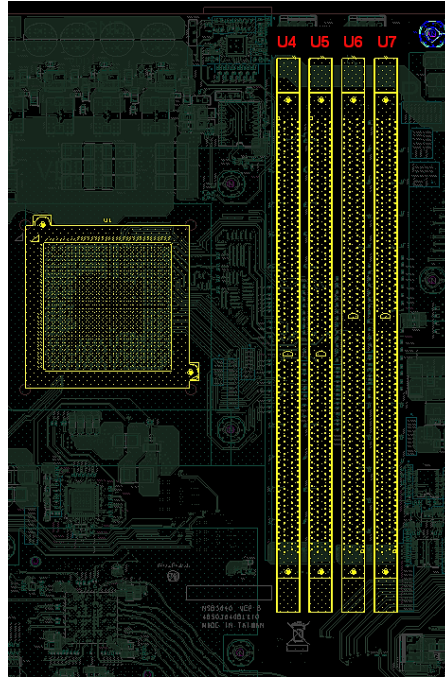
Figure 7. E-00009 workaround

E-00009: DDR rate is limited to 1866 MT/s when a single DIMM is installed

The DDR only operates at a 1866 MT/s maximum rate when a single DIMM is installed (for each controller). Rev. C and earlier boards do not support two DIMMs per controller due to the erratum E-00004.

On Rev. E and later boards, U4 location is swapped with U5 location. Similarly, U6 location is swapped with U7 location. The figure below shows the swapped locations.

For Rev. E and later boards: Two DIMMs per controller is supported; DDR rate is 1866 MT/s. One DIMM per controller is supported; DDR rate is 2133 MT/s.

On Rev. E boards, DDR operation at 2133 MT/s requires the removal of DIMM at U5 (for DDR controller 1) and U7 (for DDR controller 2). The DDR DIMMs are relocated and rewired on Rev. E and later boards to provide optimal DIMM location signaling. The Figure below shows the changes in the DDR DIMM locations for Rev. E and later boards. Basically, U4 – U7 have been repositioned to provide optimal signal integrity when only one DIMM is installed. When installing one DIMM per controller to achieve 2133 MT/s speed, the DIMM should be installed at location U4 (for DDR controller 1), and at U6 (for DDR controller 2).

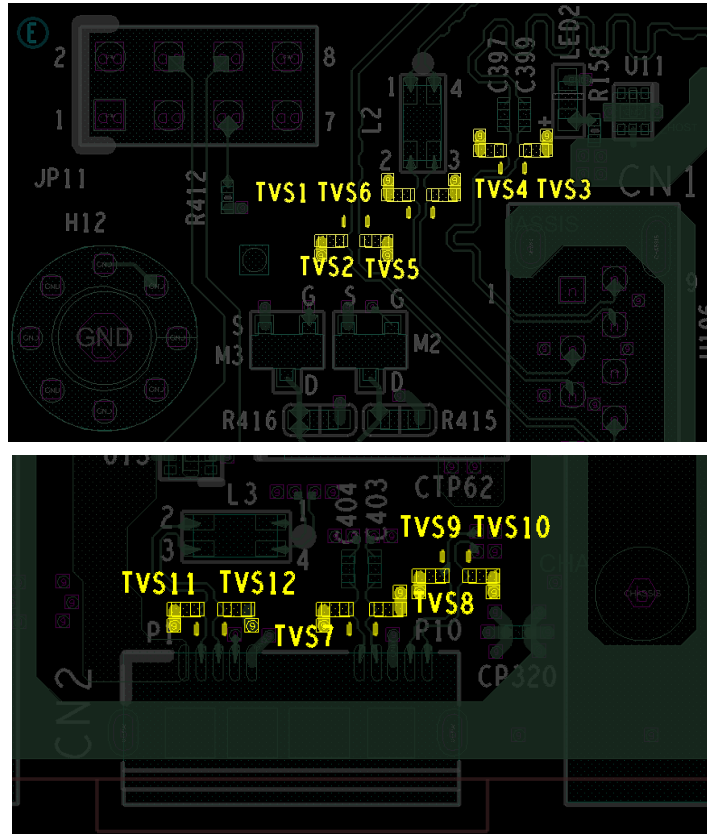
Figure 9. E-00011 workaround

E-00011: USB 3.0 SuperSpeed devices train only to USB 2.0 (high speed) mode

On both USB ports, the USB 3.0 devices (SuperSpeed devices) detects in a USB 2.0 (high speed) mode. SuperSpeed = 5 Gbit/s, high speed = 480 Mbit/s. The ESD protection devices (AZ4012-01F) have excessive loading capacitance (40-50 pF).

The USB 3.0 devices will not train at the SuperSpeed mode (5 Gbit/s) and fall back to 480 Mbit/s.

Remove the ESD protection devices, TVS2 to TVS5 and TVS7 to TVS10. This solution is required for Rev. C and earlier boards. No change is required on Rev. D boards as these ESD protection devices have already been removed from the board during the assembly process before shipping.

For Rev. C and earlier boards, remove the ESD protection devices, TVS2 to TVS5 and TVS7 to TVS10. For Rev. D boards, these ESD protection devices have already been removed. The permanent fix will be implemented on Rev. E and later boards as listed below.

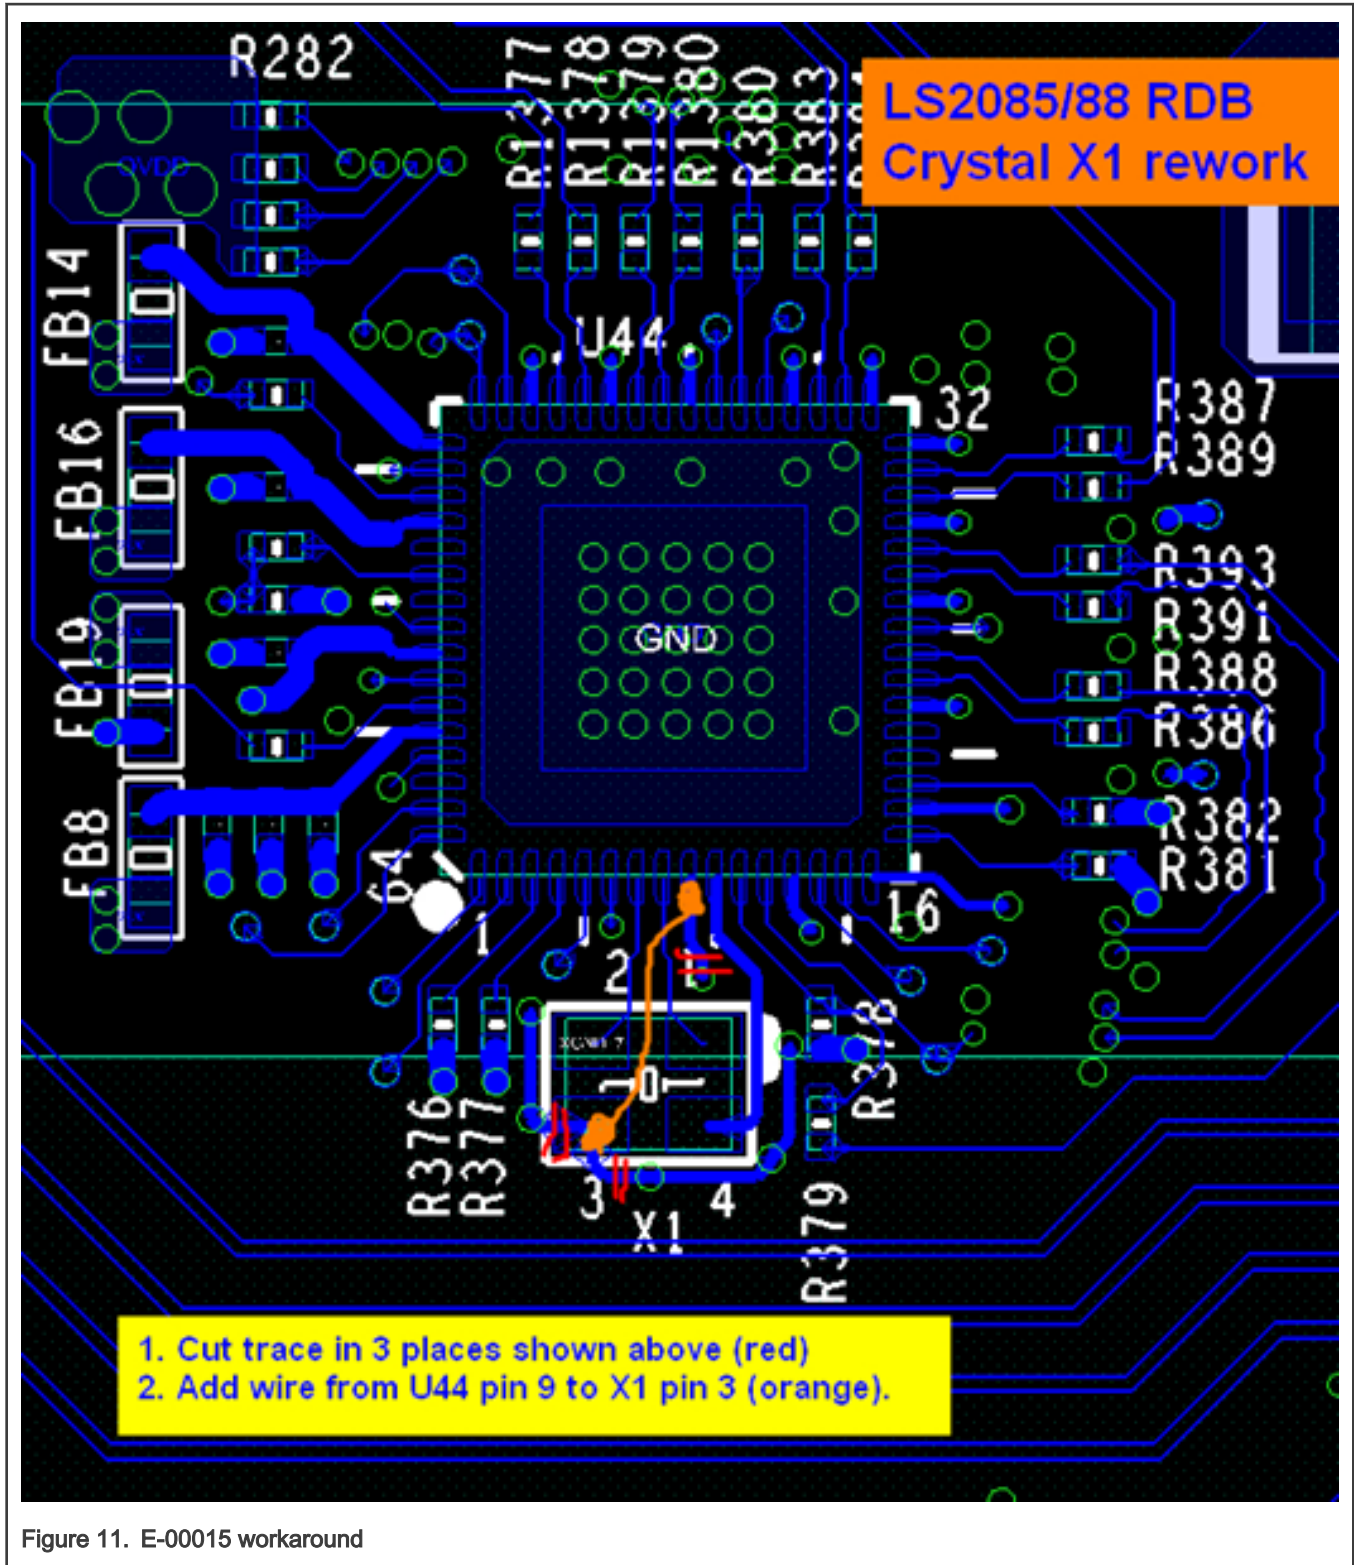
Figure 11. E-00015 workaround

E-00015: Main clocking source frequency out of tolerance

Board layout issue has excessive capacitance on crystal X1 pin 3 (net XB_Si5341B). Due to excess capacitance, the frequency tolerance of all clock outputs from U44 is slightly out of specification (too slow at approx. -100 ppm).

Ethernet traffic may exhibit some bit errors on some boards.

Cut three traces as shown in the figure below and add a wire from U44 pin 9 to crystal X1 pin 3.

Rev. F and later boards have correct layout to remove excess capacitance. No other correction is required.

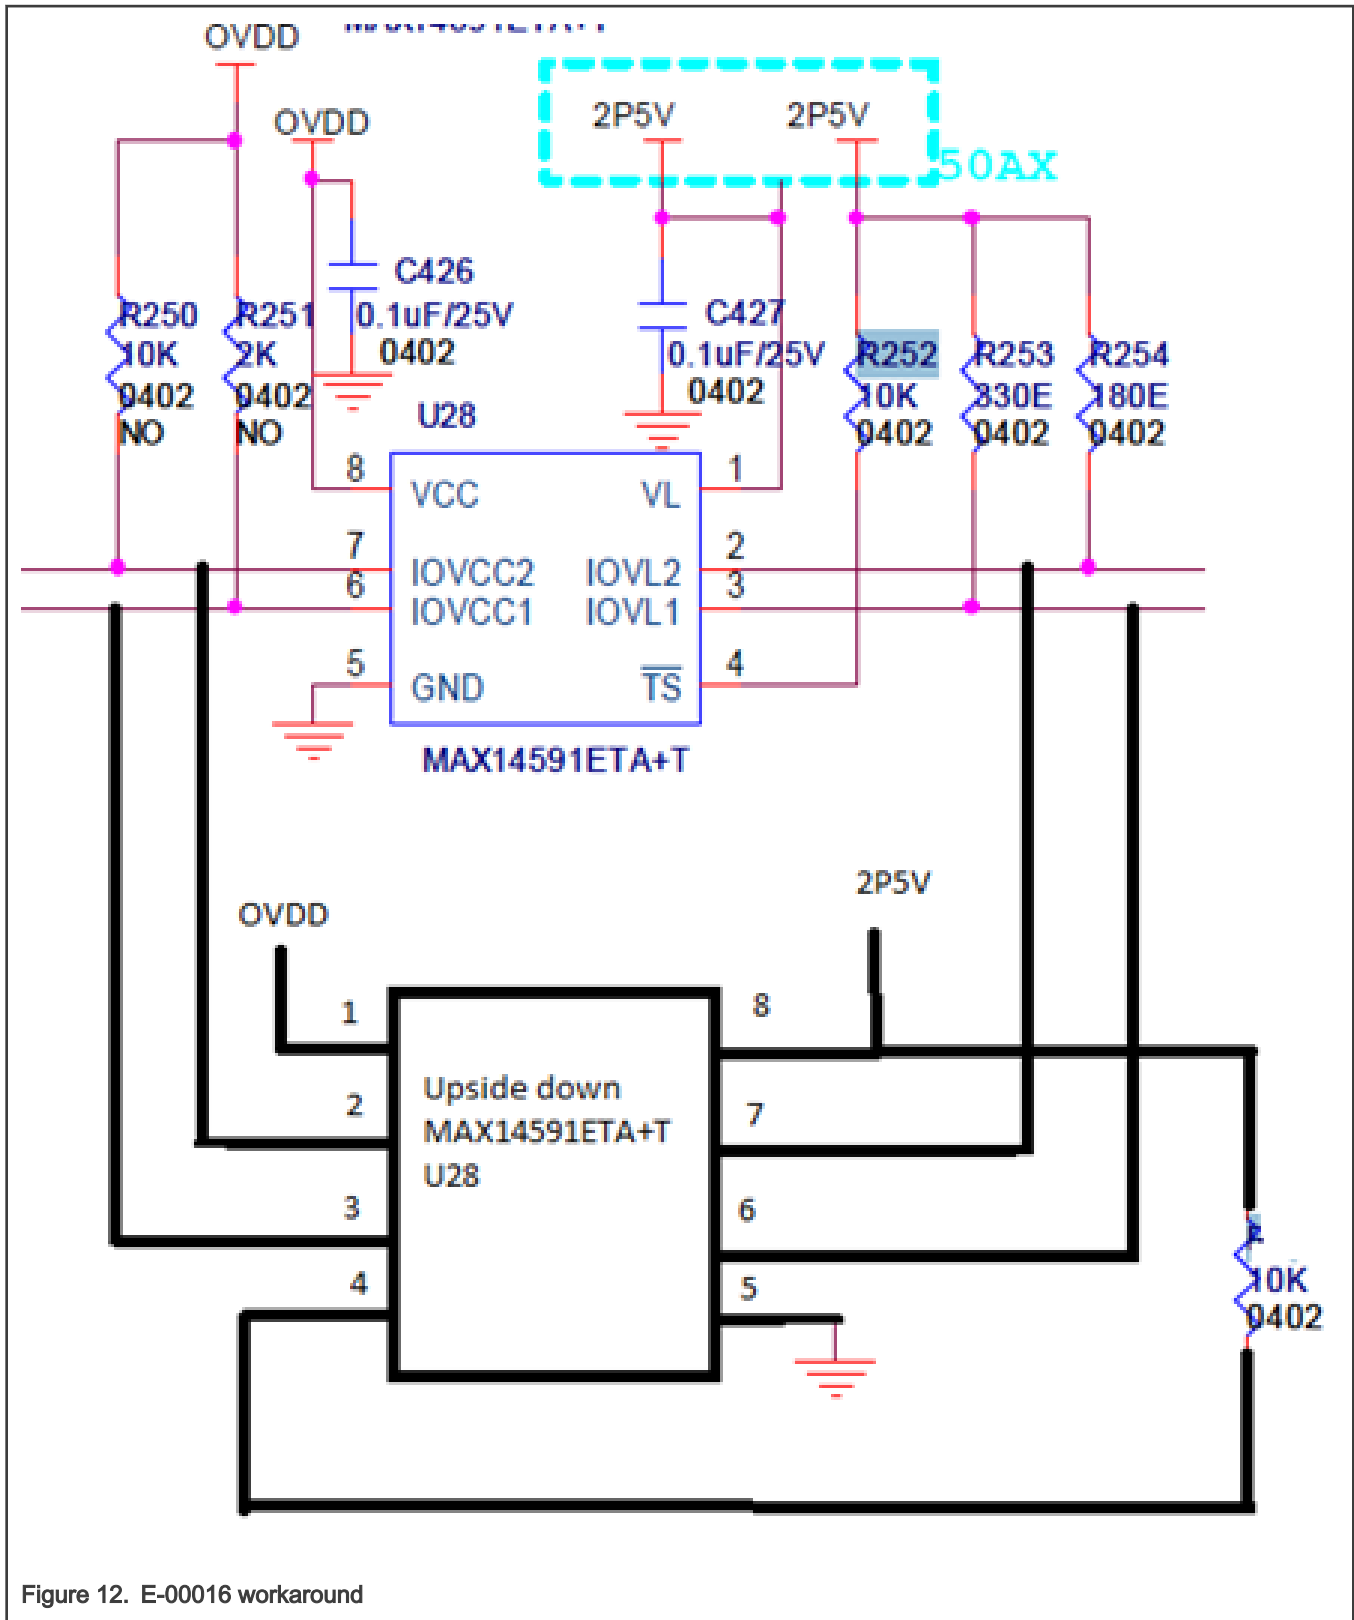
Figure 12. E-00016 workaround

E-00016: Unable to access AQR405 through EMI2 bus (MDC/MDIO)

Rev. E boards only: The voltage signaling interface on the EMI2 (MDC/MDIO) bus has been changed from 1.2 V to 2.5 V on Rev. E boards. This change was requested by Aquantia for the AQR405 device. The change to 2.5 V levels requires flipping the voltage translator U28 backwards, which is not done in Rev. E board. The U28 voltage translator does not work with the new 2.5 V levels unless it is reversed.

Software cannot access and configure the AQR405 (10GBase-T) PHY over the EMI2 bus, unless board is reworked to reverse U28.

Remove U28 from the PCB pads and re-wire as described below:

Remove U28 and flip chip and re-wire the pins as shown in the figures below. This is required because VL must be equal to or lower than VCC.

Rev. F and later boards have U28 wired as shown in the diagram above. No other correction is required.
