ES_LPC435x/3x/2x/1x Flash

Errata sheet LPC435x/3x/2x/1x flash-based devices

Rev. 6.8 — 24 September 2019

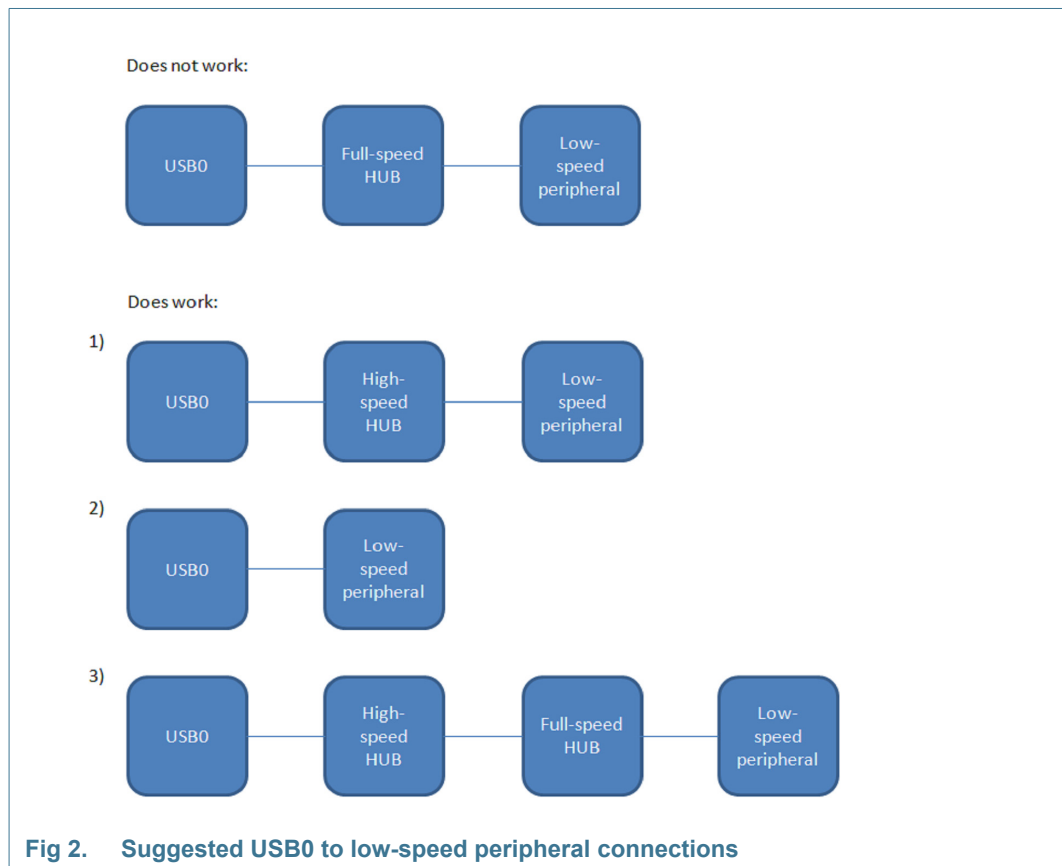
Fig 2. Suggested USB0 to low-speed peripheral connections

The USB controller called USB0 is unable to communicate with a low-speed USB peripheral in host mode when there is a full-speed hub directly connected to the USB0 port and a low-speed peripheral is connected in the tree somewhere below this full-speed hub. Only USB0 has this problem; the other USB controller, USB1 does not.

There is no work-around for this problem. It is suggested that the low-speed USB peripheral is either connected directly to USB0 or a high-speed hub is placed between that peripheral and USB0.

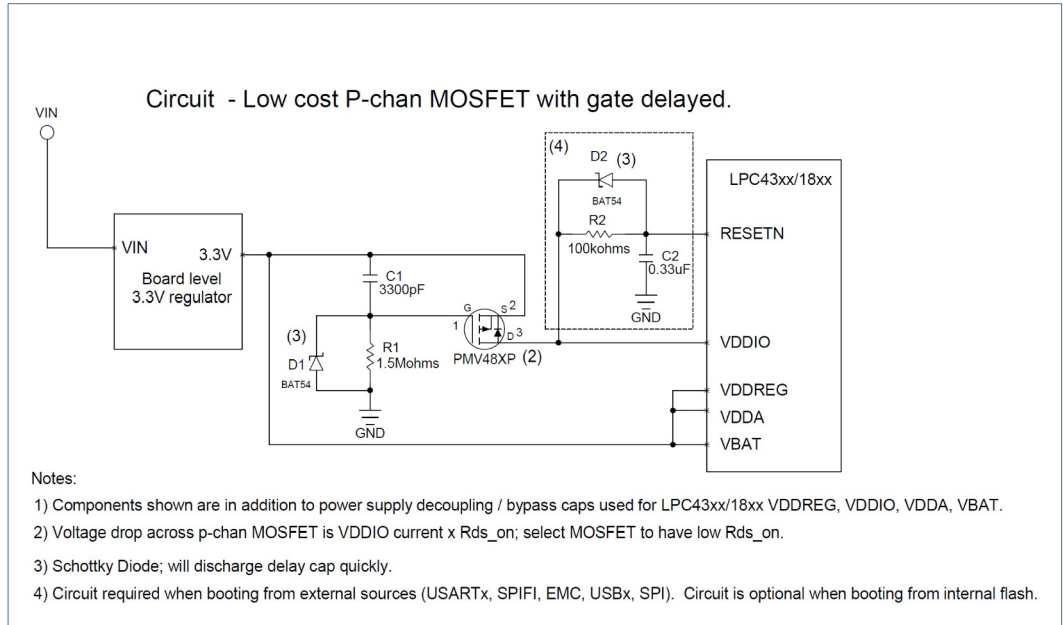
On all packages, repeated power cycling of the device may cause erroneous programming of the OTP banks. During ramp-up, the VDDREG supply voltage does not have enough time to settle and initialize the OTP controller before valid programming voltage is reached on the VPP pin. This may cause accidental programming of the OTP banks. Accidental programming of the OTP banks does not occur during power-down of the supply voltage.

- Boot from internal memory:
 - When VDDREG, VDDIO, and VDDA pins are tied together, the supply voltage must have a linear ramp-up time of at least 2 ms.
 - When VDDREG, VDDIO, and VDDA pins are not tied together, the power supplied to the VDDIO pin should be delayed by 2 ms after the power supply on the VDDREG and VDDA pins stabilizes at the operating voltage level.
- Boot from external sources (USARTx, SPIFI, EMC, USBx, SPI):
 - Do not tie VDDIO to VDDREG and VDDA pins. The power supplied to the VDDIO pin should be delayed by 2 ms after the power supply on the VDDREG and VDDA pins stabilizes at the operating voltage level. The signal to the RESETN pin must also be delayed by 2 ms after the power supply on the VDDIO pin stabilizes at the operating voltage level.

The following circuit diagram is an example that shows the P-channel MOSFET with the gate delayed and the R-C delay circuit connected to the RESETN pin.
