Mask Set Errata for Mask 0L31N

This mask set errata applies to the mask 0L31N for these products:

- MC68HC908EY16
- MC68HC908EY8

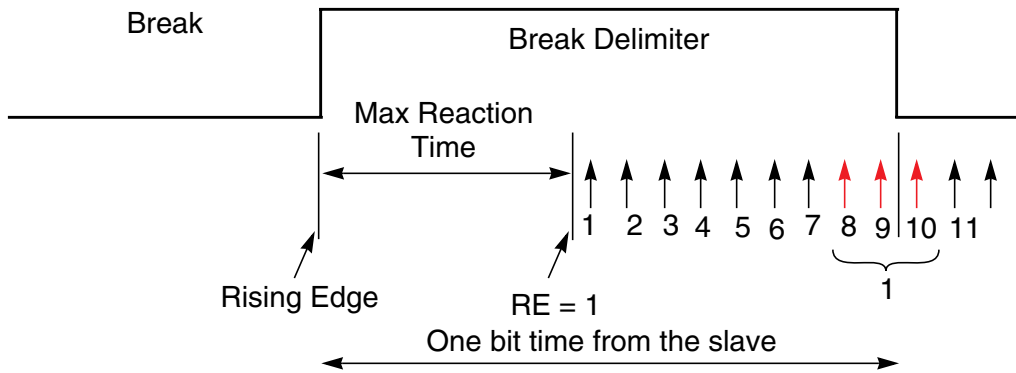
Figure 1. Maximum Time for Other Execution

The time between when the rising edge actually appears on the receive pin and when the receiver is switched back on is finite and is governed by the timing of the falling edge of the delimiter. The receiver must be switched back on no later than 9/16th of a bit time before the end of the delimiter. See Figure 1.

From Figure 1, we also see that the "Maximum Reaction Time" is $7/16^{th}$ slave bit-time.

The Maximum Reaction Time for this example system is 7/16 x (44.5 µs) = 19.47 µs.

From the instant the rising edge appears on the receive pin (detected via the arbiter AFIN bit or a timer interrupt), the software has to switch the receiver OFF and back ON within 19.47 µs.

One way to properly sample the BREAK delimiter is to switch off the receiver after the rising edge of the delimiter is detected by the arbiter, wait a clock cycle and switch back on the receiver. This will reset the internal sampling clock and will insure accurate recognition of the delimiter.

1. Clear RE to disable the receiver, execute a NOP, then set RE to re-enable the receiver
   - The purpose of the NOP instruction is to prevent a C compiler optimization from deleting this step.
2. Clear appropriate flags if needed and exit the ISR.
